REPORT  
of the  
COMMISSION  
on the  
ACCIDENT INVOLVING  
AIRCRAFT SE-BDY

**REPORT OF THE COMMISSION TO INQUIRE INTO  
THE ACCIDENT INVOLVING AIRCRAFT SE-BDY**

“The cause or causes of and circumstances surrounding the accident involving aircraft SE-BDY near Ndola during the night of the 17th September, 1961, including any matter or circumstances relating to the preparation for and flight of the aircraft, the accident, the deaths of the occupants, and the conduct of any person or authority concerned before, during and after the accident.”

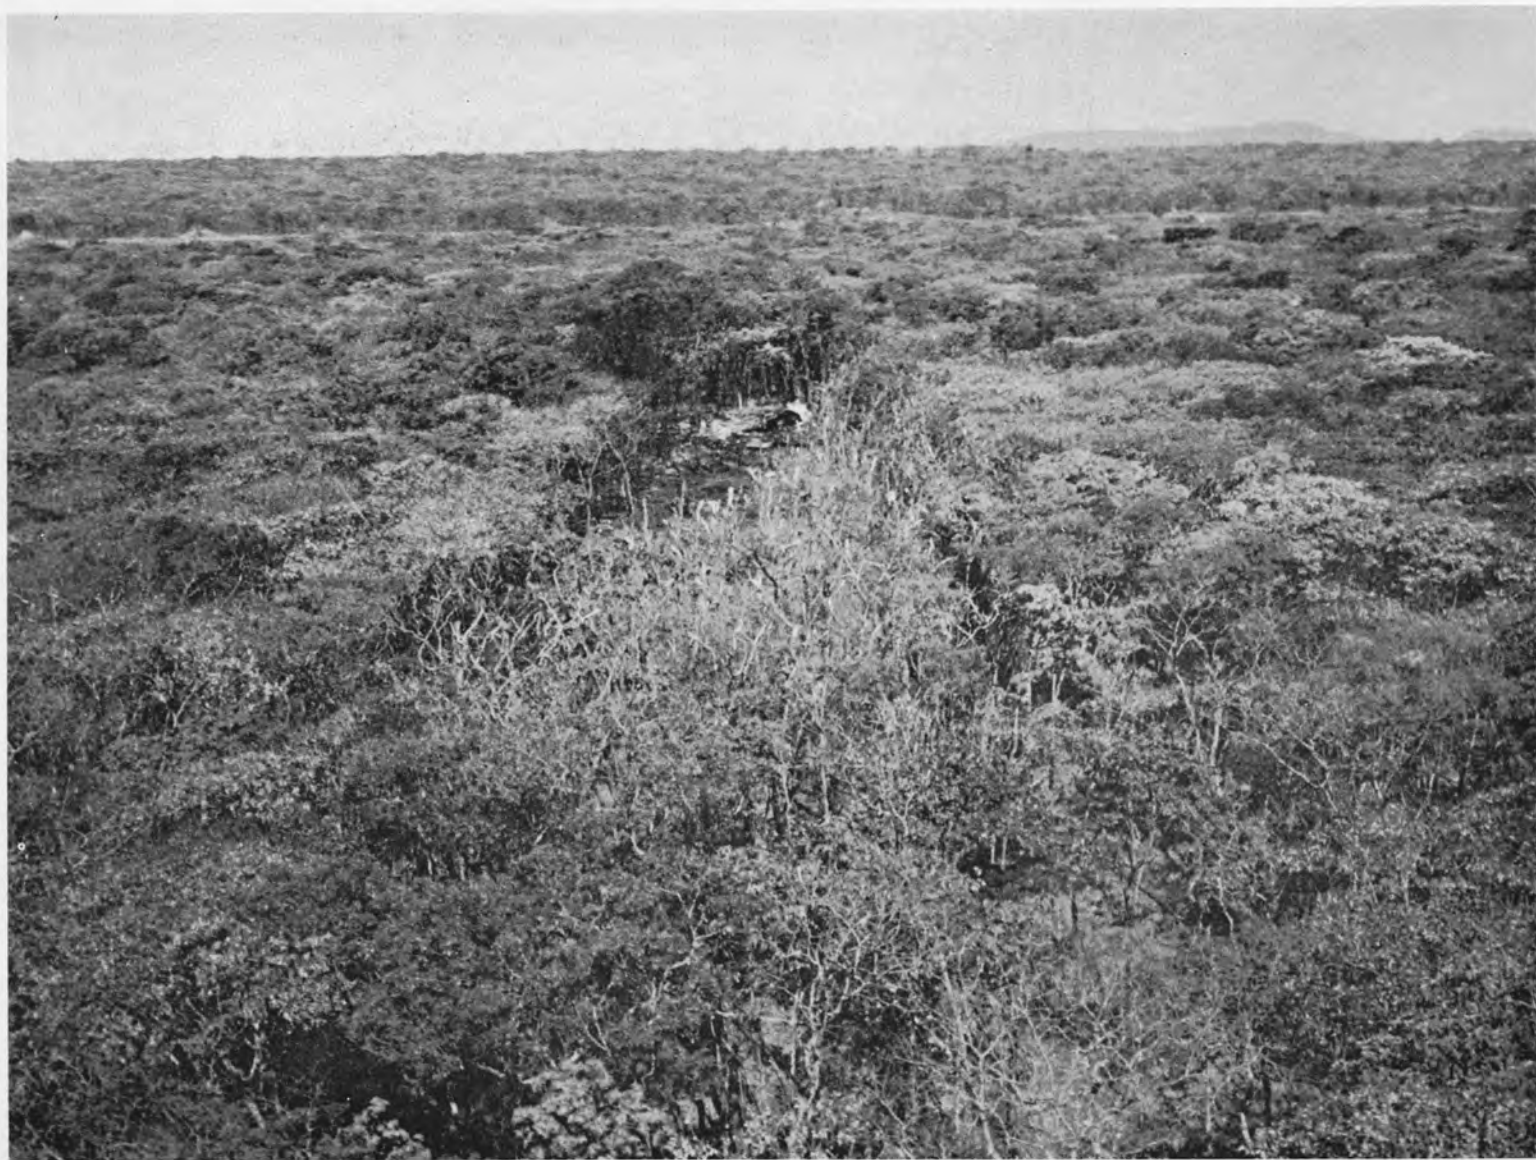
PHOTOGRAPH No. 1

*Approach path illustrating narrowing swath cut by aircraft as left wing down attitude increased*

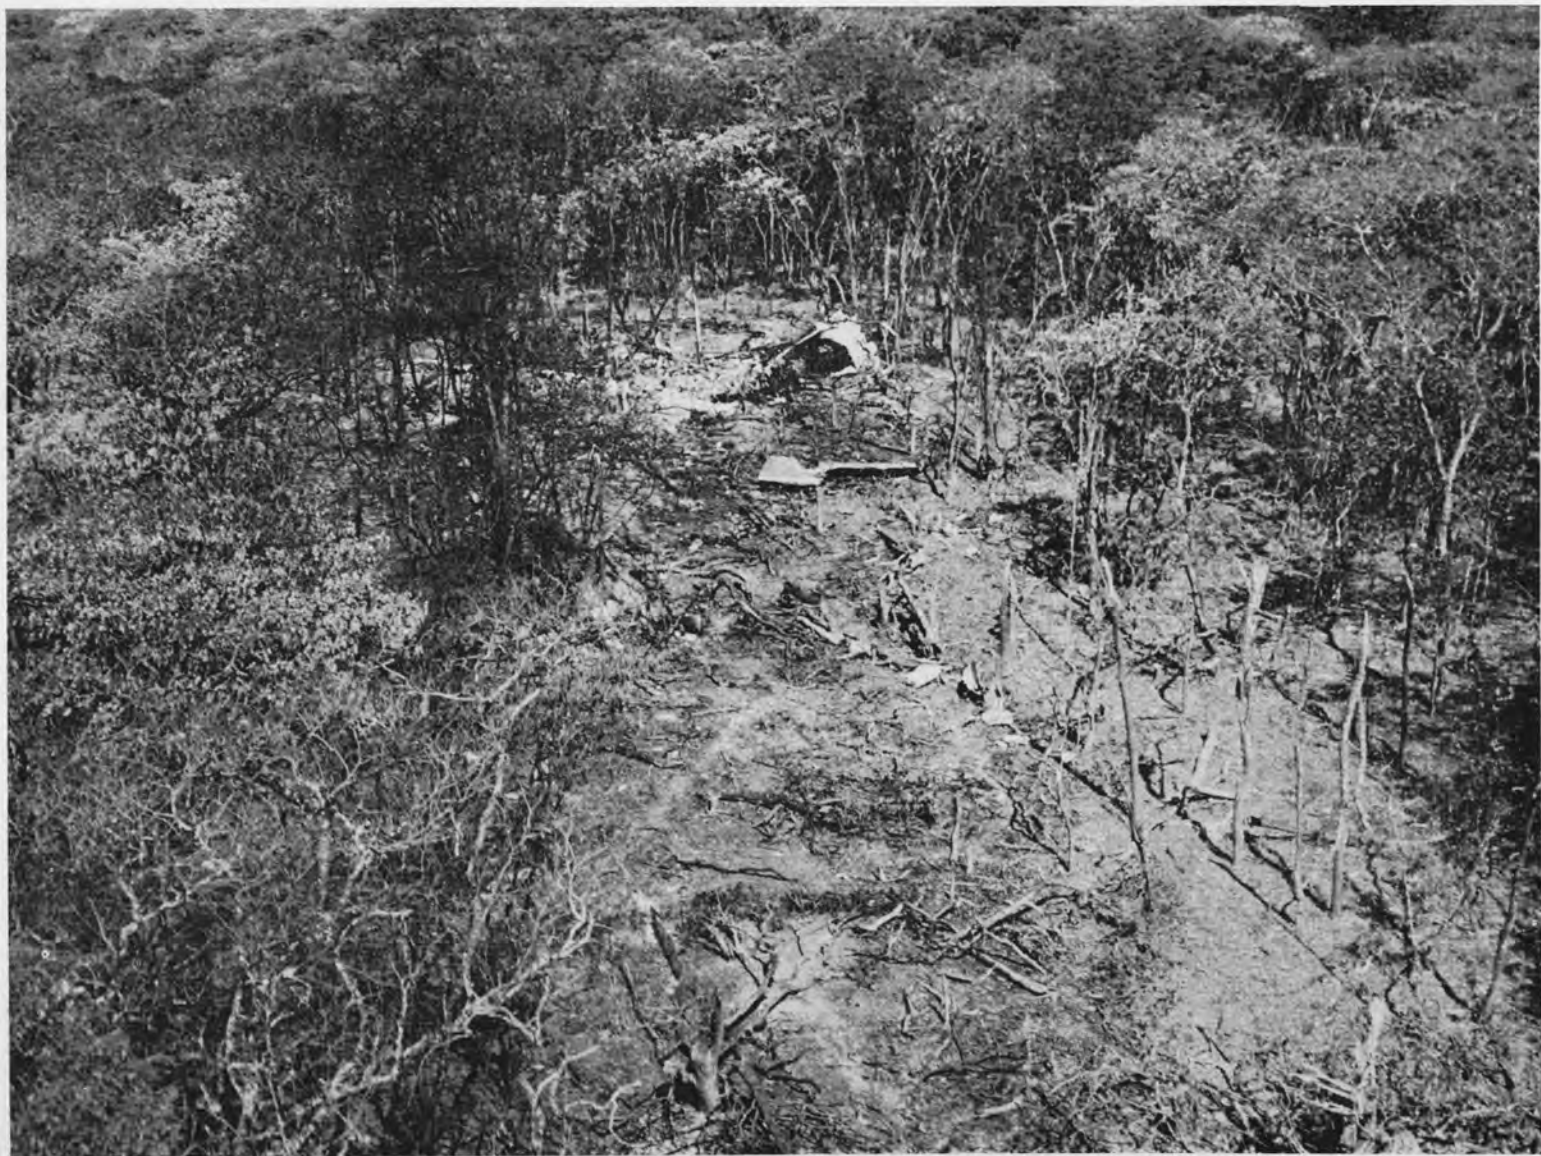
PHOTOGRAPH No. 2

*Main wreckage area showing ant-hill struck by aircraft nose in centre left of photograph and last 300 feet of wreckage trail*

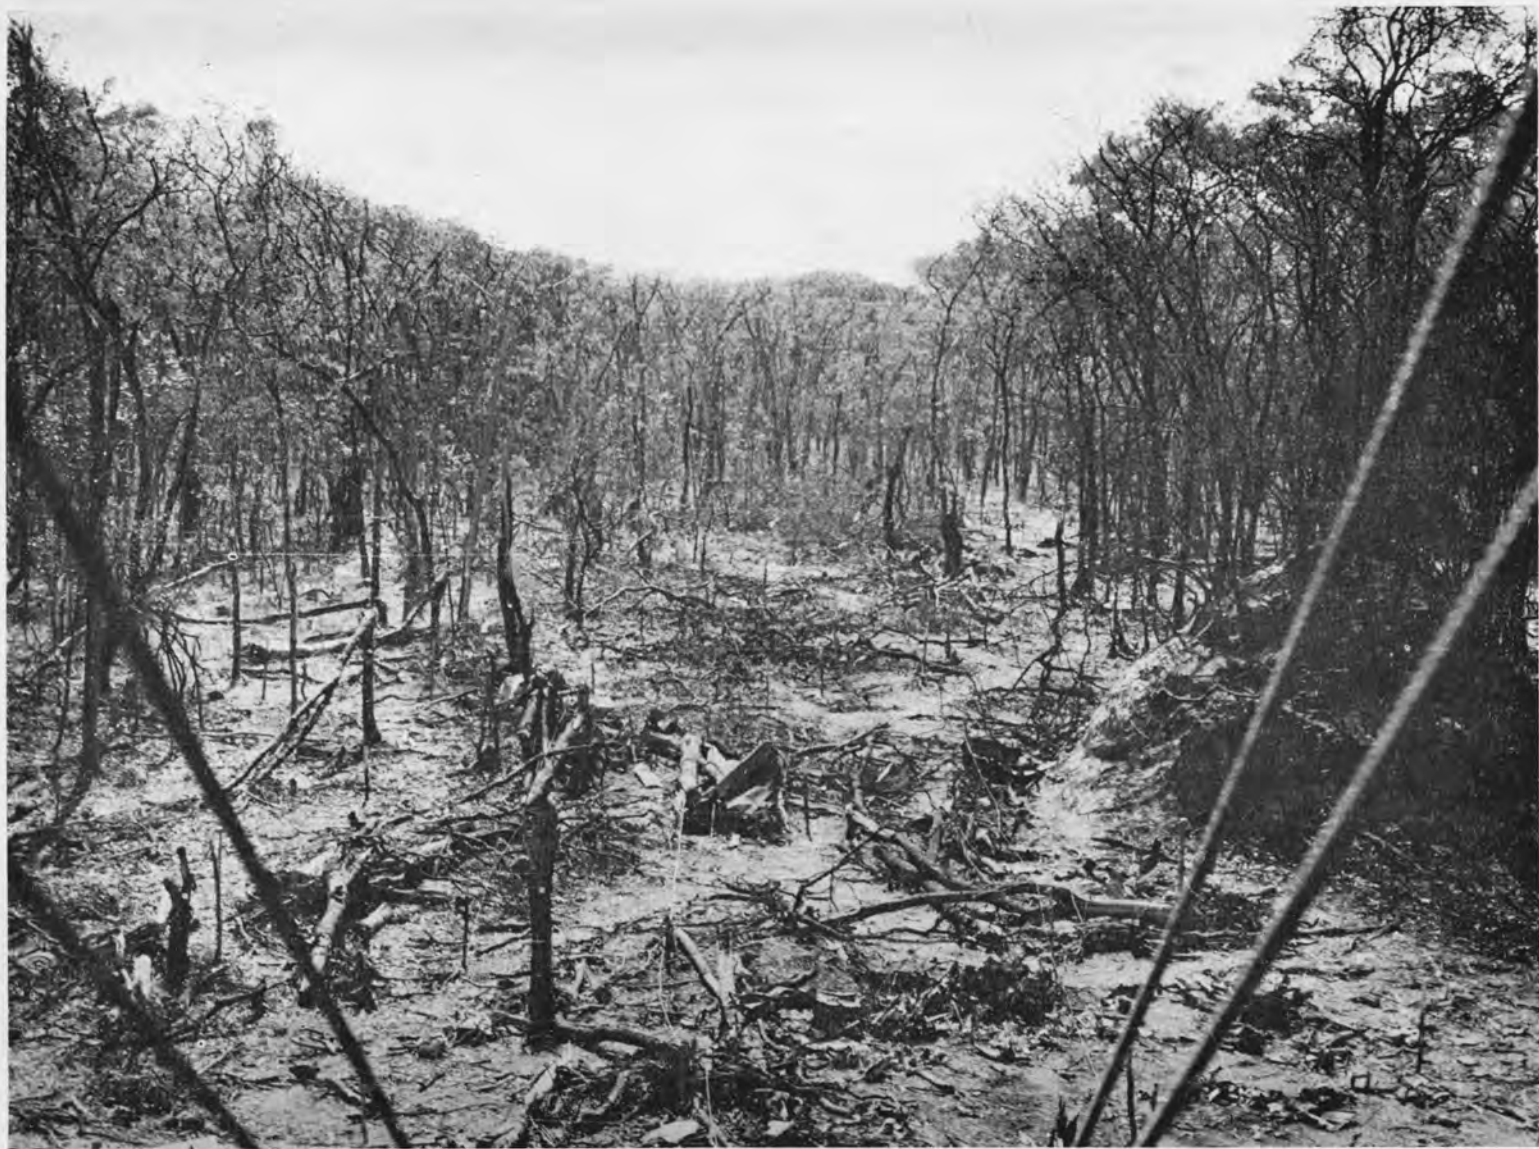
PHOTOGRAPH No. 3

An accurate survey of the scene of the wreckage, with measurement of the heights of the trees where they were damaged, shows clearly that the aircraft hit the trees at a normal angle of descent. There were no holes in the ground or scars in the ground to indicate steep descent. The measurement from the first tree damage to an anthill which the aircraft struck, and from which it cartwheeled to rest, shows an overall angle of 5° of descent. It is clear that with damage to the aircraft and loss of speed this angle must have been slighter initially. So that it can confidently be said that the trees were hit when the aircraft was descending at an angle of descent of less than 5°.

*View looking back along approach path showing swath cut by aircraft and the initial shallow approach angle*

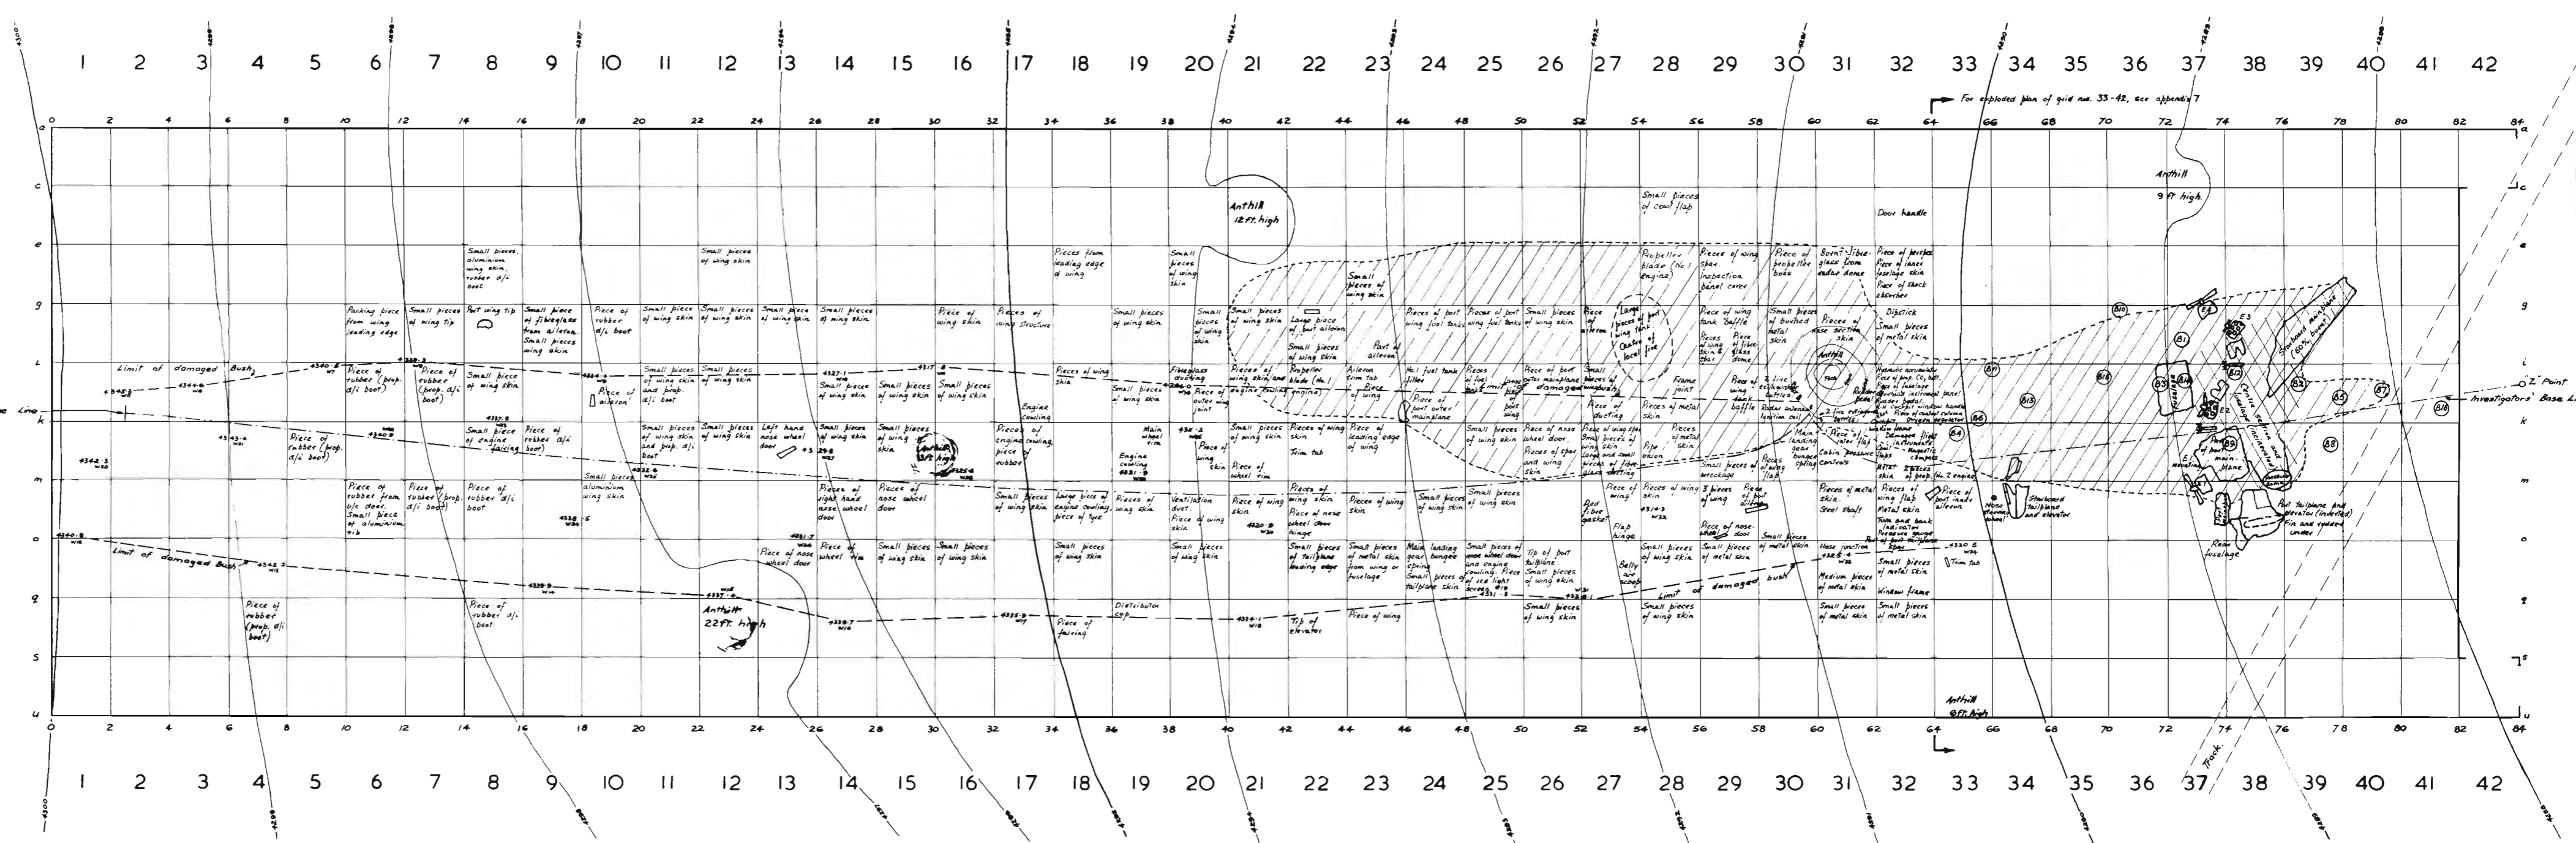
## ACCIDENT TO DOUGLAS DC-6B SE-BDY

The total length of the wreckage trail from where the trees were first hit was 800 feet. There was no sign of fire at all except in the last 400 feet. The main area of incineration was in the last 80 feet. The fire backwards on the trail from that area was probably caused by flash-back of fuel on explosion and by burning grass.
